Product: GAS ENGINE
Model: 3516 GAS ENGINE 4EK
Configuration: G3516 Engine Electronic Ignition System 4EK00001-UP

Engine News

Media Number -SEBD9318-00

Understanding Elevated Copper Levels in Used Oil Samples {1348, 7542}

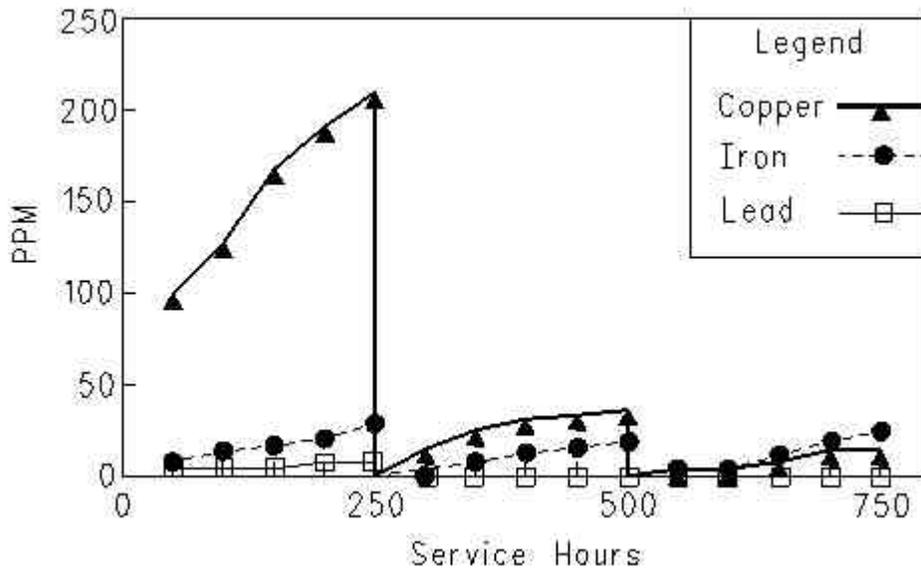
Illustration 1 represents the typical trend of copper levels. The graph demonstrates some results from analyses that were performed during the development of a project. The engine oil was analyzed at every 50 service hours and the engine oil was changed at every 250 service hours.

The engine oil samples that were obtained during the initial 250 service hours revealed an increasing copper level that exceeded 200 ppm. Between the first oil change and the second oil change, the copper level rose to less than 50 ppm. By the third oil change, the copper level was normal.
