## RGS/PUMP MOTOR SWITCH FAILURE AND REPLACEMENT

Revised 05/08

The following writeups and pictures have been packaged to cover the diagnosis and if necessary, the replacement of a failed Rotten Green Switch - - aka the pump motor switch or RGS. Since these memos were written to send out individually in most cases, there may be some duplication in content.

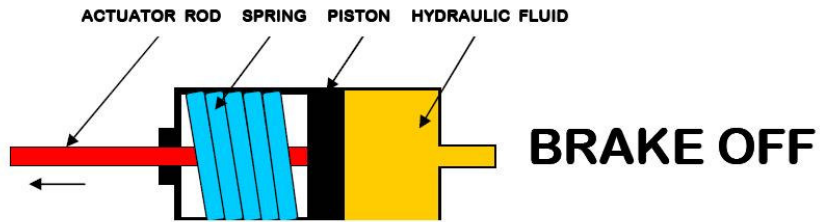
This drawing depicts the AutoPark actuator with hydraulic pressure applied. In this condition, the brake is **RELEASED**. The piston is forced to the left by the hydraulic fluid, and the actuator rod has relaxed the tension on the cable to the brake assembly.

The actuator is the heart of the AutoPark system. It is a hydraulic cylinder which applies or releases a drum brake on the driveline. It is also important to remember that hydraulic pressure **RELEASES** the brake, and that lack of pressure **APPLIES** the brake. As such, **BRAKE APPLIED** is the default condition for most malfunctions of the AutoPark system.

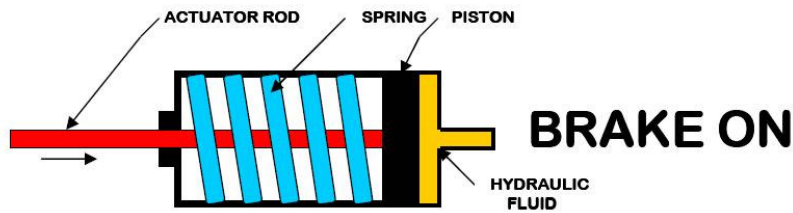
This drawing depicts the AutoPark actuator with no hydraulic pressure on it. In this condition, the brake is **APPLIED**. The piston is forced to the right by the heavy spring, and the actuator rod is putting tension on a cable connected to the brake assembly.

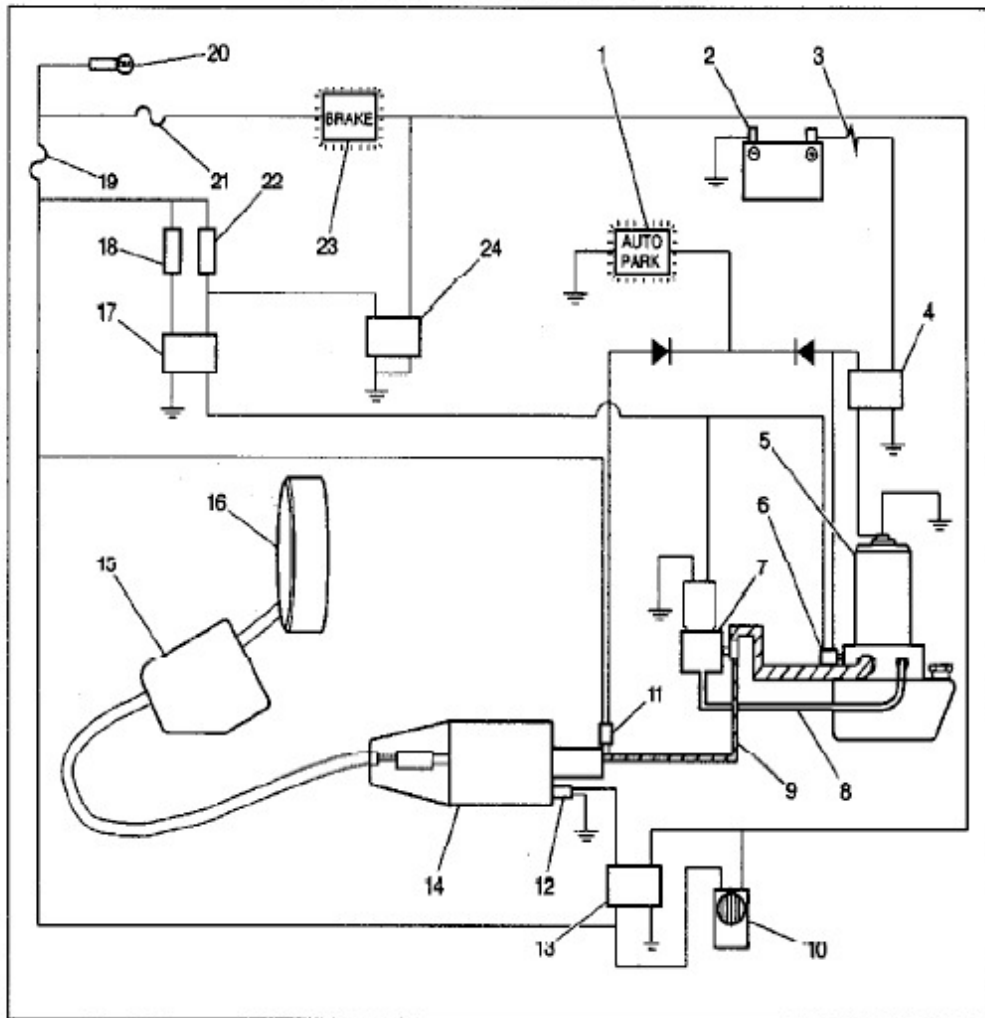
### Electric/Auto Parking Brake Components

This is the Version III system. It does NOT have the manual foot pedal, but instead has a yellow push-pull knob on the dashboard - - as well as the PARK position on the gear selector.

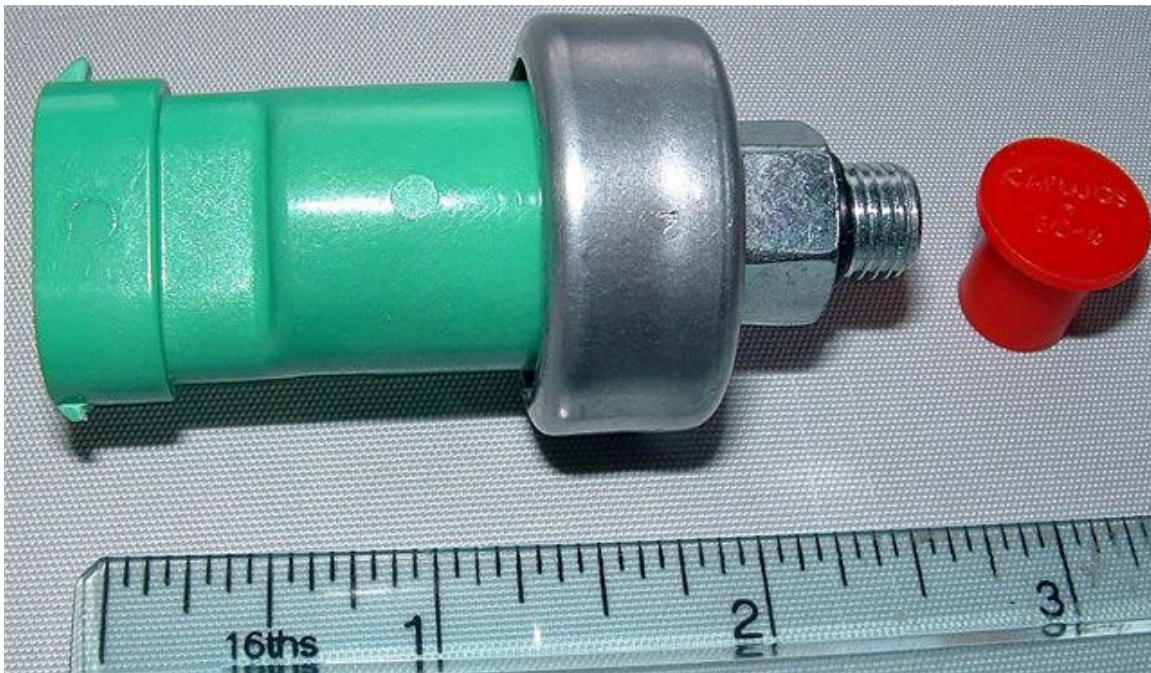
Below is a picture of a new Rotten Green Switch - - as mentioned elsewhere, it is sometimes brown in color, but the function is unchanged regardless of whether it is brown or green.

So what is the Rotten Green Switch, and what does it do? The RGS is an electric pressure switch, which controls the hydraulic pressure supplied to the actuator. It is designed to turn on the pump at pressures below 1200 psi, and turn the pump off when the pressure reaches 1600 psi.

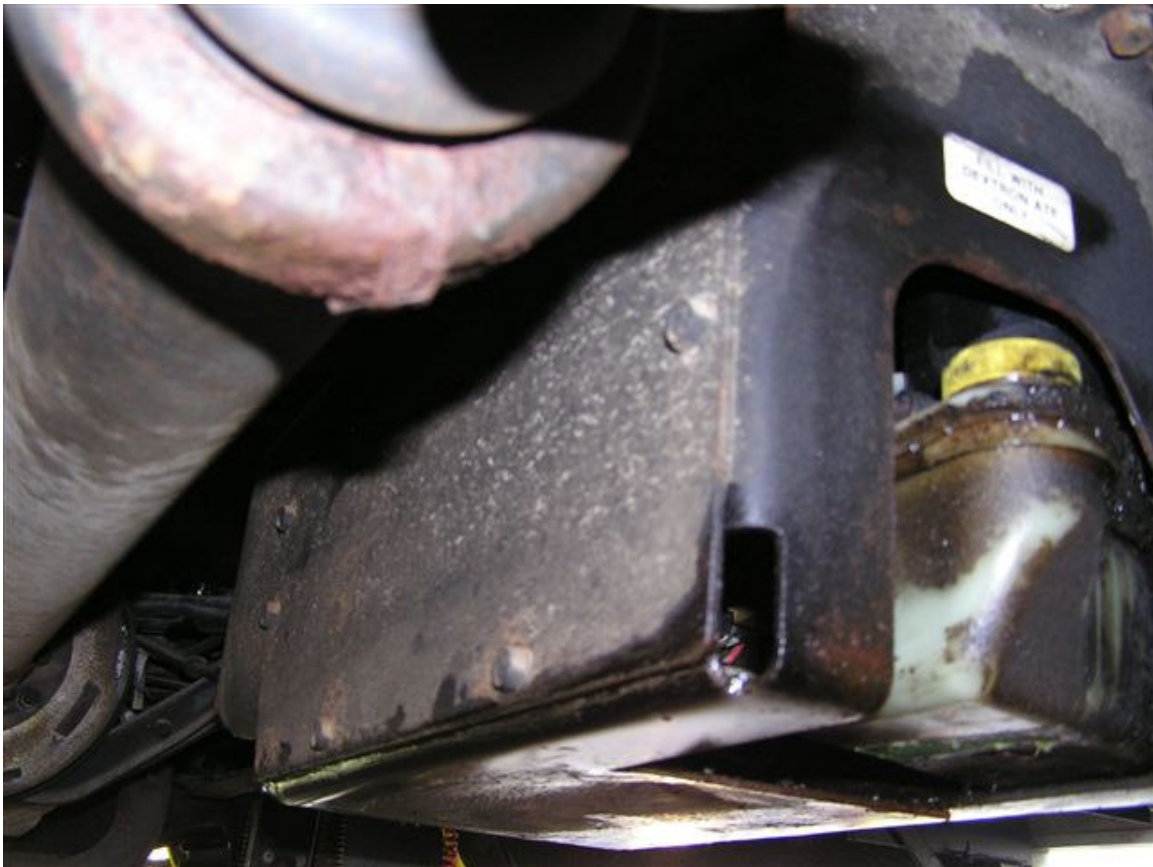
**Chock your wheels - - you'll be getting under the rig unless it is a 2001 or later in which case the pump/reservoir and RGS are up in the front of the coach - - driver's side by the radiator. Earlier models look on the passenger side of the tranny next to the frame rail, but slightly aft of the tranny itself. You should see the reservoir easily but will probably have to remove a sheet metal plate to see the AutoPark mechanism and the RGS. It looks like this:**

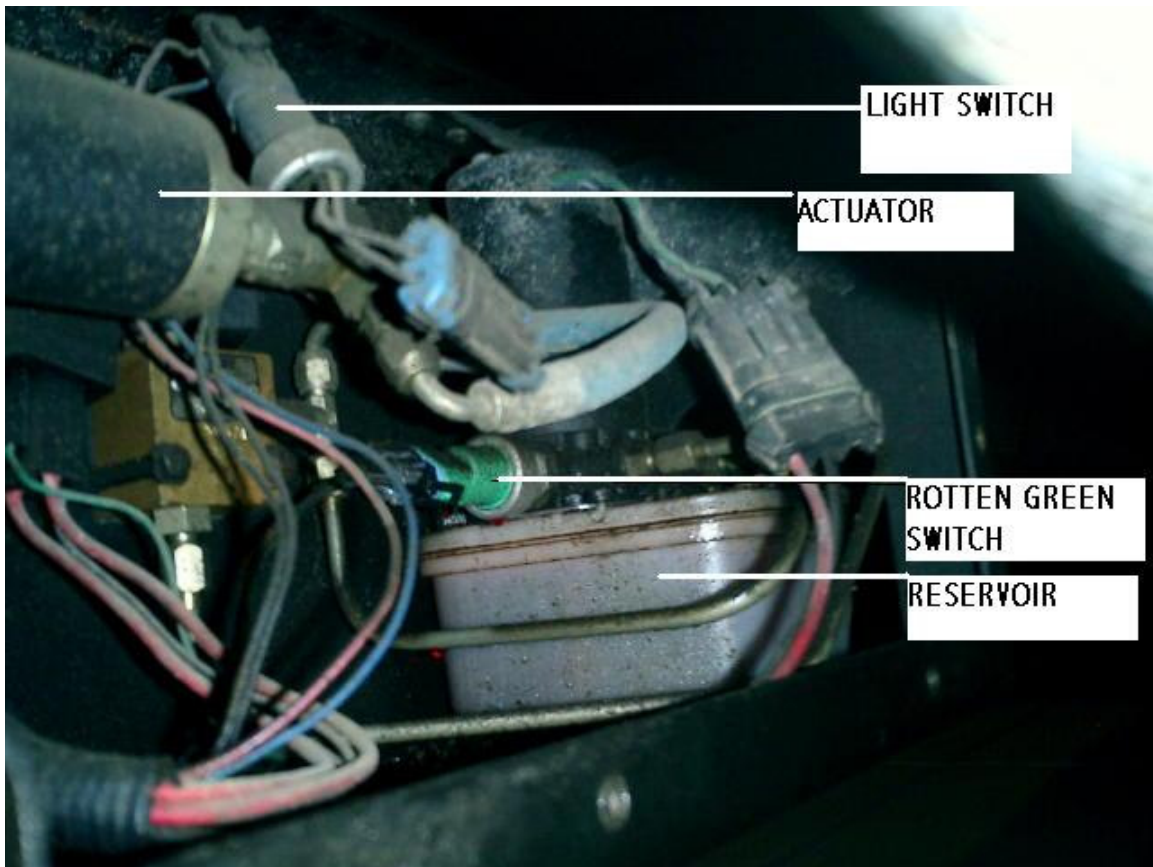
With the lid removed, the Goodie Box will look much like this inside:

This particular picture is of a 95 version. The newer units have a plastic reservoir but the general layout is much the same.

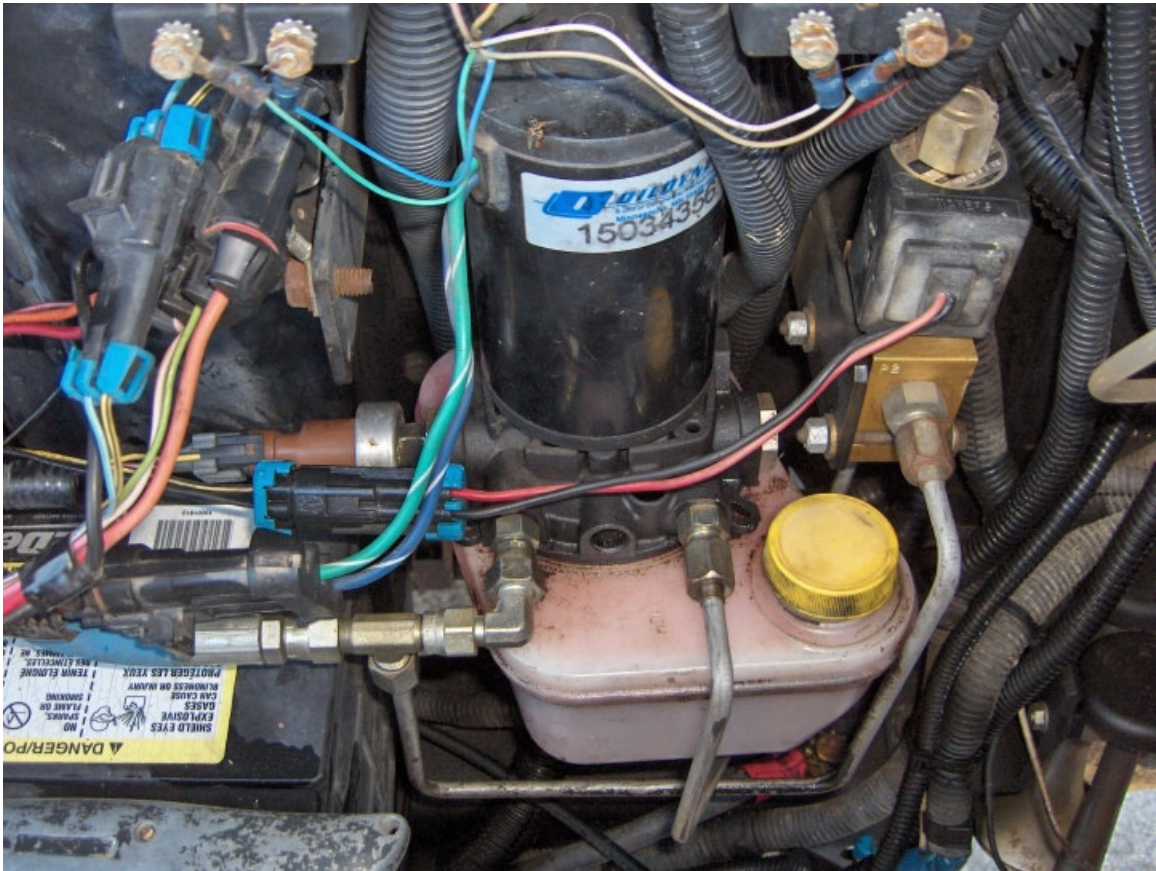
If you have the later version with the pump located up front under the utility hood, to the driver side of the radiator, it will look more like this:

Notice that the newer version (of the Parker pump) has a Rotten Brown Switch instead of a Rotten Green Switch. If your pump does NOT look like the first picture, you may have the Pump/motor that is made by MTE - - (second picture). Both the Oildyne and the MTE perform the same functions.

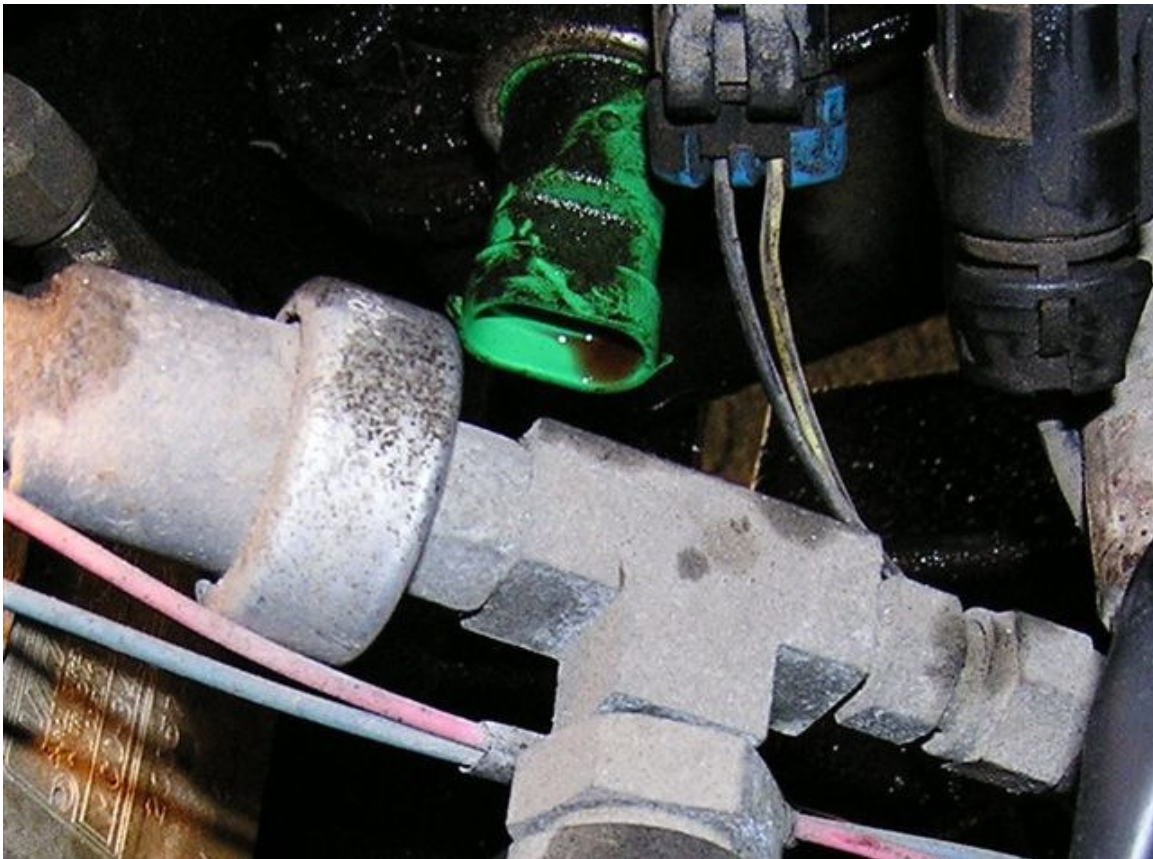
**If the AutoPark lite stays ON, and especially if the pump does not shut off, locate RGS and see if it is oily. Pull the wire connector off of the RGS, and see if there is oil inside the connector. If there is, you need check no further - - it is bad. Here is a picture of a leaking/oily RGS:**

Even if the RGS is NOT OILY, you will still want to remove the electrical connector from it. If AutoPark lite GOES OFF after disconnecting the plug on the RGS (ignition still ON), then you have confirmed that the RGS is bad.

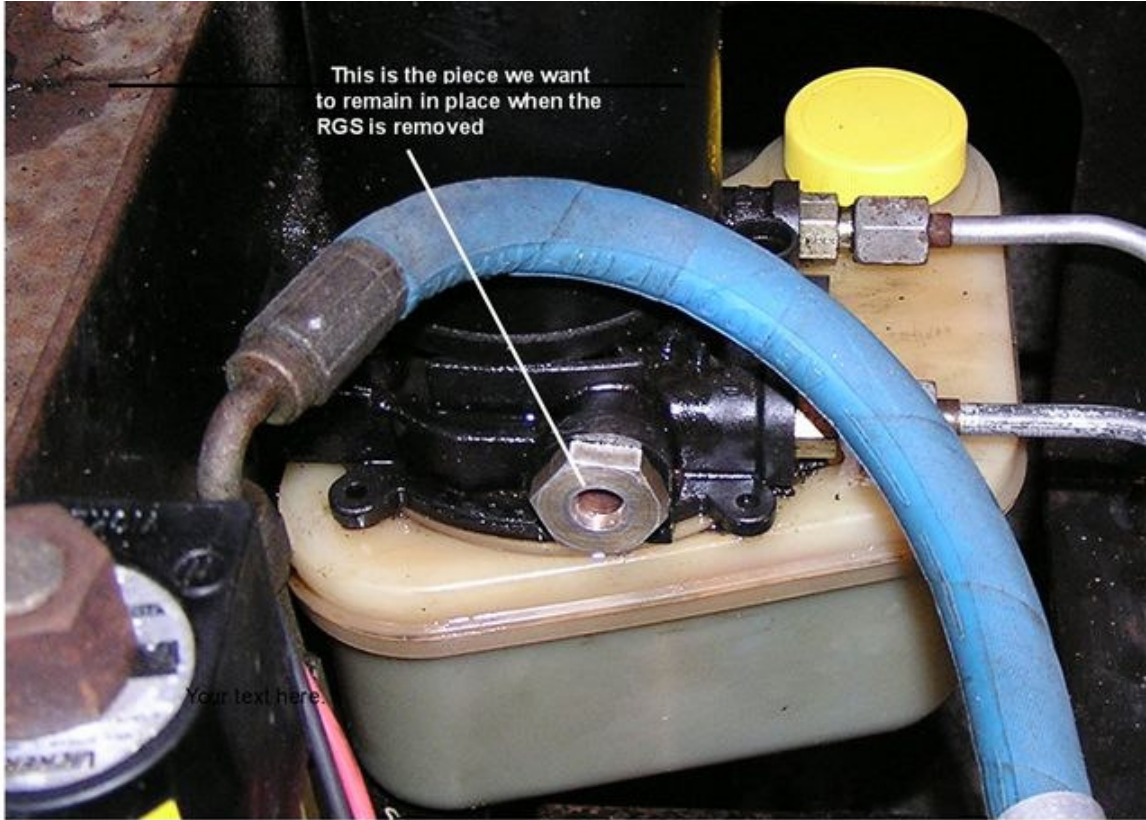
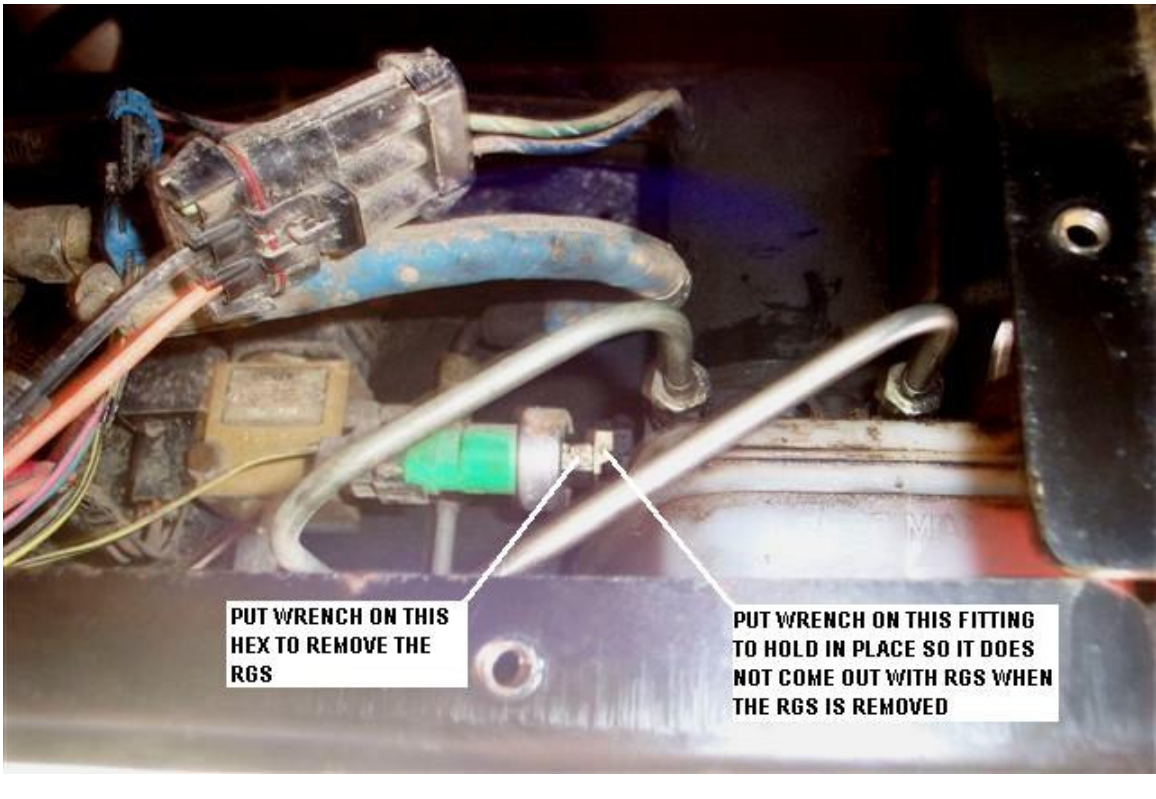
**We have attached a pair of pictures on the following page that help to explain the above problem. In the picture below, it is important to note that the shiny hex adapter is made of very soft material, and it is pretty easy to strip the threads by overtightening the RGS when threading it into the adapter.**

The picture above shows the RGS installed - - screwed into the hex adapter which in turn is screwed into the pump base.

The RGS threads into a piece that looks somewhat like a pipe reducer. We call it a "poppet valve hex reducer." For short, the PVHR. One end of the PVHR has a 3/8 24 female thread the RGS screws into. The other (male) end screws into the pump body itself -- not a pipe thread I'm told. Several people have said that they bugged the female thread in the PVHR (which accepts the RGS) in the process of installing the new RGS -- and have thus found it necessary to drill out the old threads, and re-tap the hole to something larger. Then, they made a newly threaded bushing to fit the RGS on one end, , and to fit the PVHR on the other. Sort of sounds like a Helicoil repair for those who are familiar with that process. At this point, we don't as yet know diameters or thread pitches -- just the basics of the repair.

*Consequently, anyone replacing an RGS should be aware of the potential problem.* For whatever reason this hex valve fitting may be removed, the mechanic must be careful not to lose any of the parts of the poppet assembly. We do have an annotated picture of the system that shows and labels the RGS and the hex reducer. We also have (courtesy of the pump manufacturer), exploded views of the poppet assembly and corresponding part numbers, in the event someone should lose any of these pieces. The obvious way to avoid these miseries is to remove **ONLY** the RGS and **NOT** the hex reducer which retains the poppet assembly.
